Denver's Forgotten Flood

The Geomorphologic Impacts of the 1933 Castlewood Dam Failure

Kaelin M. Groom and Casey D. Allen

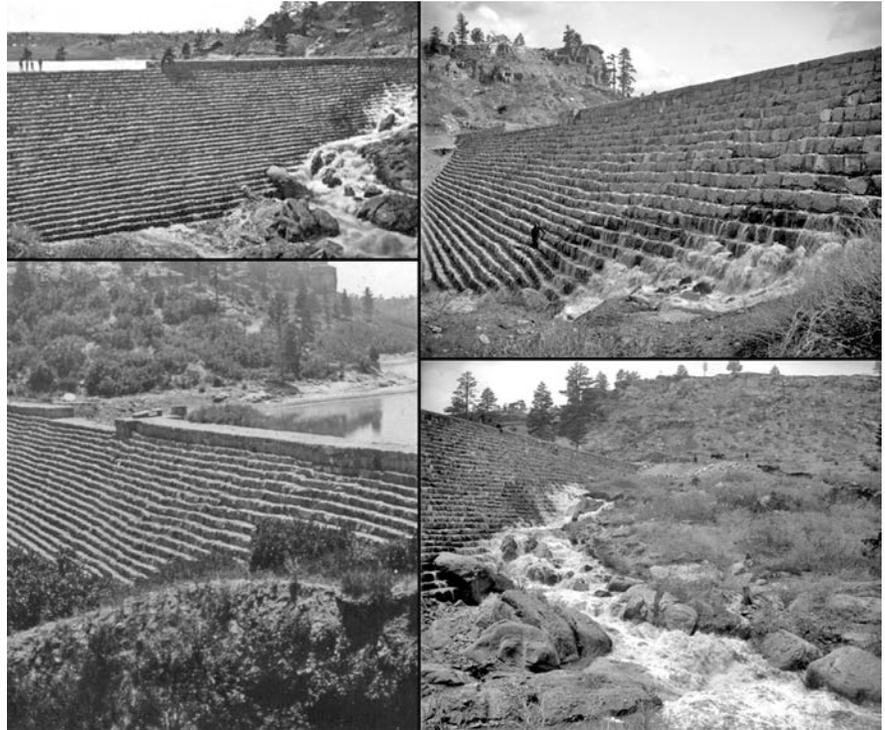
From the moment the dam began impounding any significant amount of water, it began to leak (Figure 1). Countless reports were filed by a number of government and private agencies ensuring the dam's safety but the dam's stability was publicly debated continuously until the day it failed. Local newspaper headlines ranged from "Castlewood Is Safe" (*Rocky Mountain News*—1896) to "Castlewood Dam Not Over-Strong: Engineer Ryan Doubts That It Can Withstand a Flood" (*The Denver Republican* — 1900) and other such contradictions were released nearly annually. Eventually, in 1900, A. M. Welles wrote a letter to *The Denver Post* newspaper defending his work:

Figure 1. Dating 1890–1910, these images show the Castlewood Dam’s infamous leak with several men for scale. The dam seeped for the entire 43 years it was in use and was a great concern to those residing downstream. Photos from the Colorado Historic Society and Castlewood Canyon State Park.

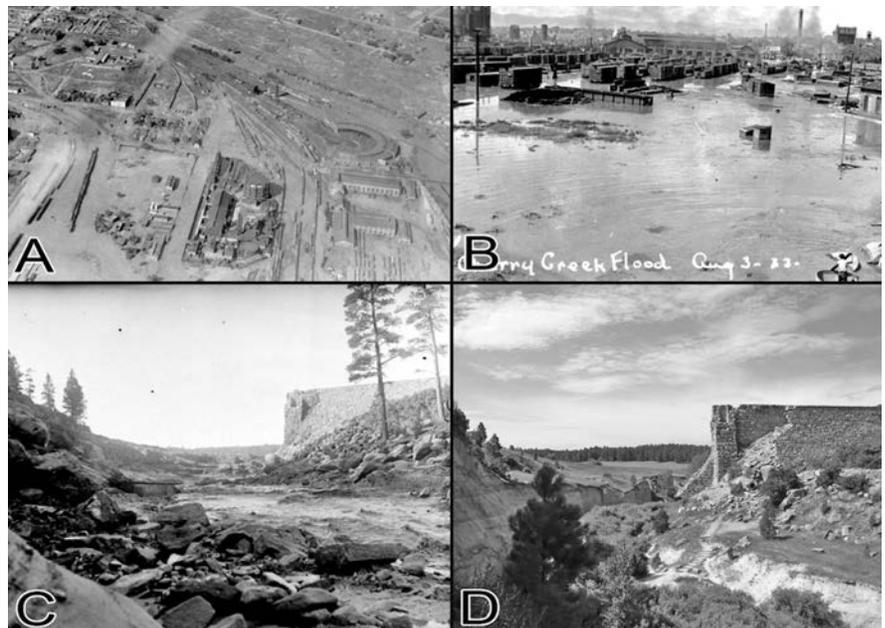
Figure 2. These images show the various impacts of the 1933 Castlewood Dam failure. Photo A, from the Colorado Historic Society, shows an aerial shot of Denver’s famous Union Station completely inundated. A little closer to the ground, photo B from the Denver Historical Society displays the flooded train yard. Photo C, from the Colorado Historic Society, is the breached dam the day after the flood and photo D is the dam ruins today by Kaelin M. Groom.

The sustained damages were extensive totaling \$1.7 million in 1933 currency, nearly \$30 million today.¹³ Union Station, situated downtown, was beneath a meter of water, with the basement and baggage subways entirely inundated (figure 2). Several bridges were destroyed and 15th Street was inundated with 0.6 m of water.¹⁴ Of the estimated losses, nearly \$960,000 was suffered in the farmlands upstream of Denver and additional economic damages came from the loss of water supply to over 12 square km of the surrounding area.¹⁵

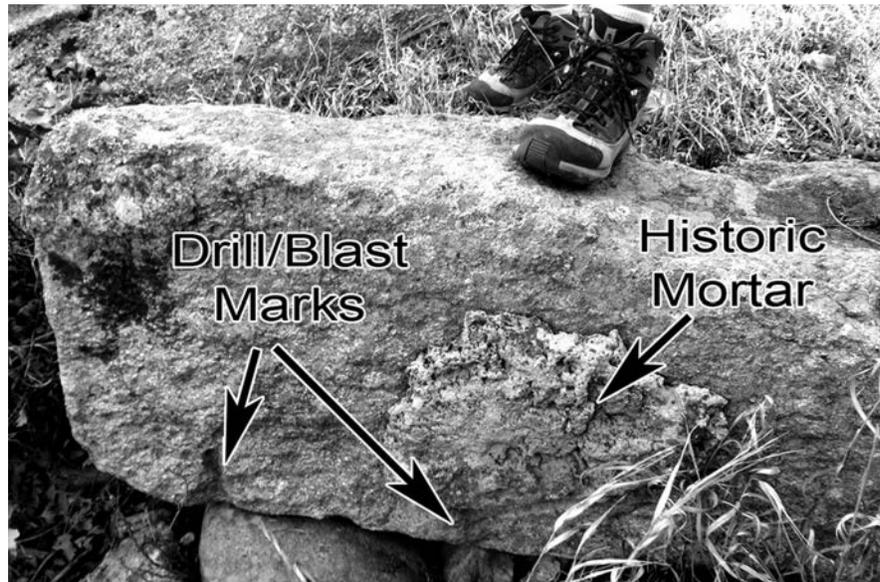
Figure 4: The identification of the masonry blocks through drill/blast marks and historic mortar. Many of the boulders near the ruined dam have both but further downstream the constant battery of the floodwaters detached the mortar and the drill marks become the more consistent indicator. *Photo by Kaelin M. Groom.*

still attached to the boulders. Very distinct from the local geology, thin slabs of mortar are easily recognized. Unfortunately, much like the drill marks, this characteristic is only valid for a certain distance downstream before the erosive power of the flood debris detached the cement from the blocks. Many clasts close to the dam have both drill marks and attached mortar, verifying the method of identification, but downstream the drill marks are more reliable (figure 4).

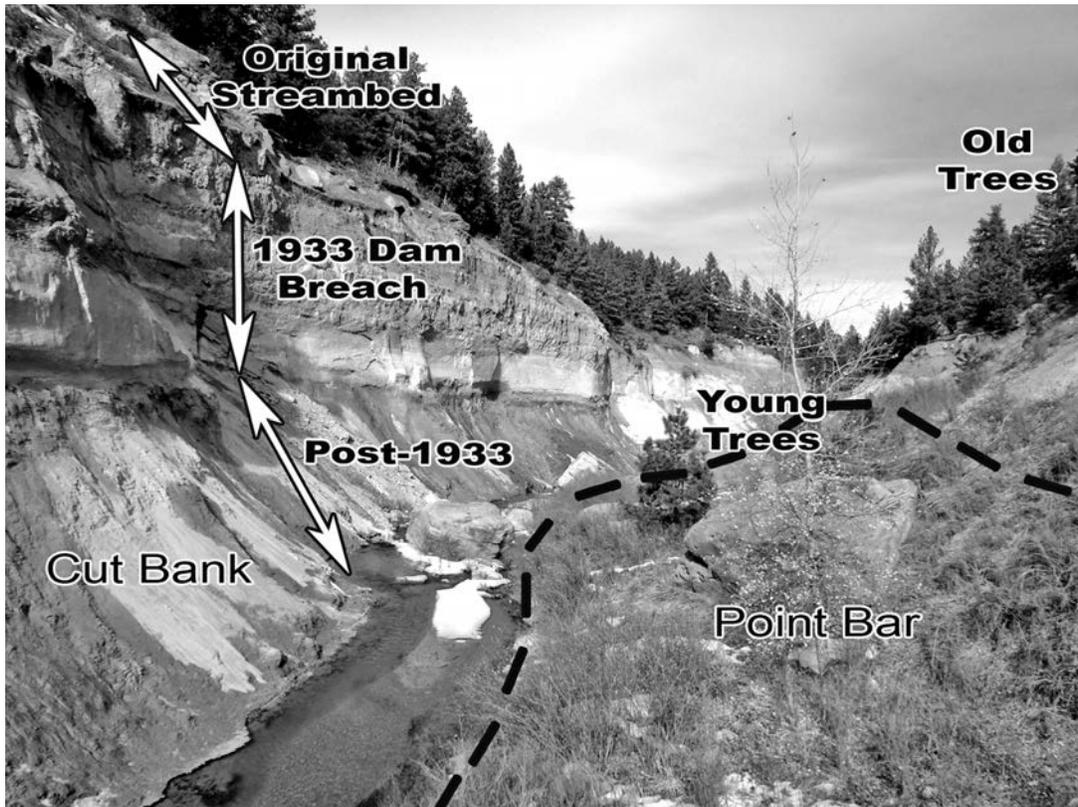
Figure 6: Image of the three terraces downstream of the dam. Note the slight undercutting at the base of the 1933 flood terrace denoting the vertical limit of subsequent floods. The distinct contrasts of tree sizes within and without the flood zone also serves as a high water mark. Photo by Kaelin M. Groom.

Distinct flood terraces, 1933 paleoflood debris deposits, and well-defined previously buried soil profiles made the lower canyon a unique study reach for obtaining cross sections. Three specific terraces can be identified: (i) the speculated original stream elevation, (ii) material displaced during the 1933 flood, and (iii) all subsequent erosion. Historic photographs and topographic maps support this assumption. Four cross sections were recorded roughly 15 meters apart to define the 60-meter study area (figure 5). Using the three levels, polygons were created to extrapolate the volume of displaced material coinciding with each erosional era: the pre-1933 flood and post-1933 geometry (figure 6).

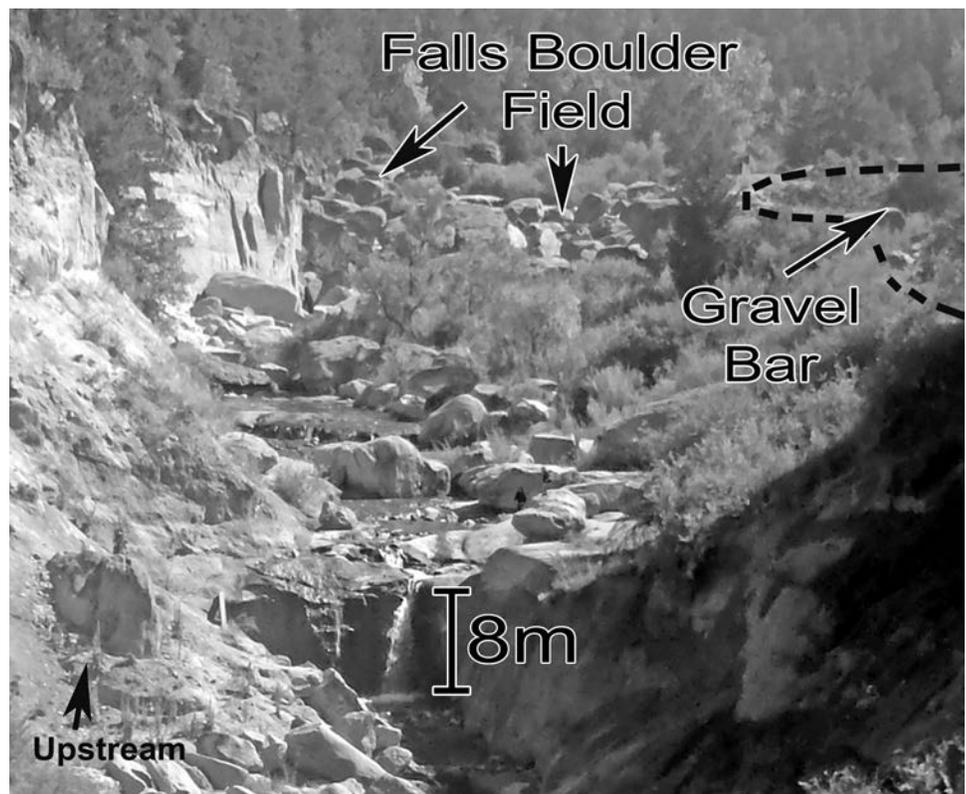
USGS and the lack of historic photographs suggest Cherry Creek was a graded stream with no existent knick points or falls directly prior to the 1933 flood. Also supporting this hypothesis is the presence of a gravel bar, a well-established maximum water-level marker and paleostage indicator (Jarrett and England, 2002),²⁴ level with the tops of the massive boulders but several meters higher than the falls. A number of dressed stones can be found on this particular gravel bar, which would normally raise questions: How were these transported here and how can they be so much higher than The Falls? But in this instance, their existence suggests that they were deposited during the beginning stages of the flood, before the falls were carved, and it wasn't until the flood became channeled as the falls deepened that the upper level became a gravel bar and high-water mark (figure 8). Whether

Figure 8: Image of the Falls and congested boulder field looking upstream. Note the two men near the falls for scale. Though not clearly visible from this angle due to vegetation, a large gravel bar extends well past the Falls. Photo by Kaelin M. Groom.
