Denver's Forgotten Flood

The Geomorphologic Impacts of the 1933 Castlewood Dam Failure

Kaelin M. Groom and Casey D. Allen

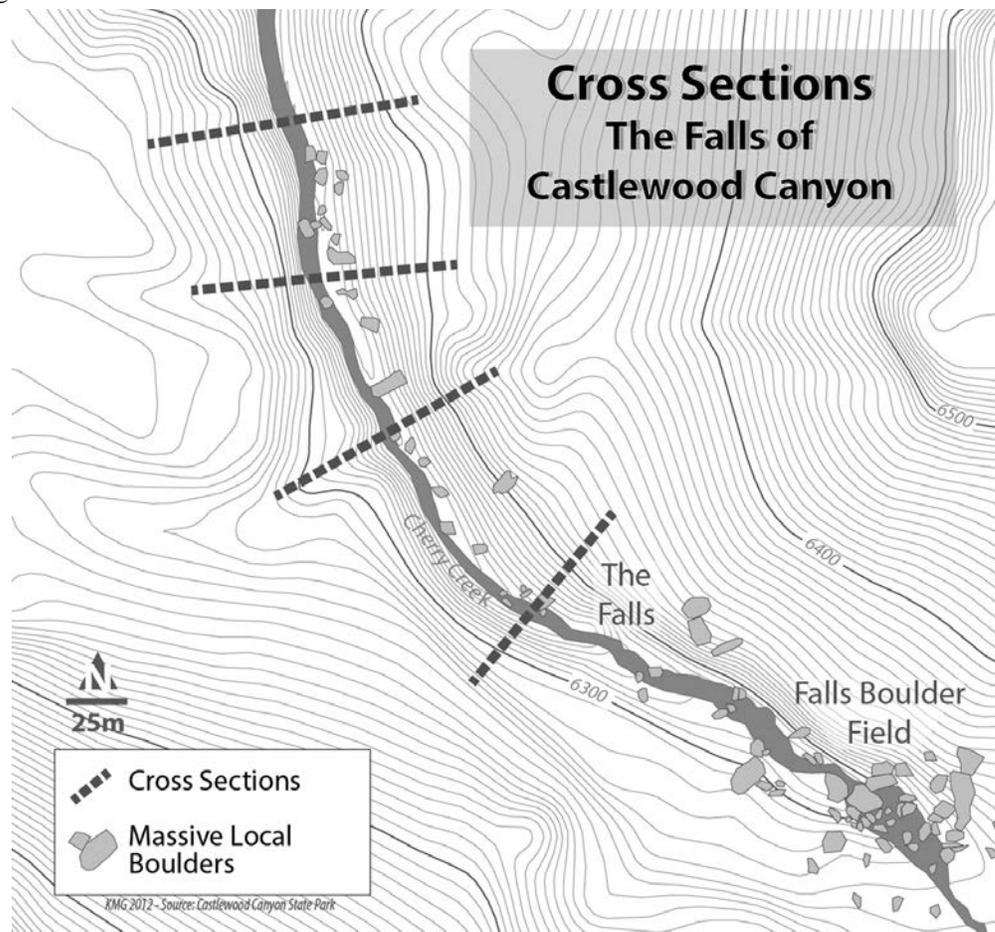
Figure 5: Map of the cross sections recorded directly downstream of the Falls shown with relative location to the Falls Boulder Field. *Kaelin M. Groom 2012.*

Distinct flood terraces, 1933 paleoflood debris deposits, and well-defined previously buried soil profiles made the lower canyon a unique study reach for obtaining cross sections. Three specific terraces can be identified: (i) the speculated original stream elevation, (ii) material displaced during the 1933 flood, and (iii) all subsequent erosion. Historic photographs and topographic maps support this assumption. Four cross sections were recorded roughly 15 meters apart to define the 60-meter study area (figure 5). Using the three levels, polygons were created to extrapolate the volume of displaced material coinciding with each erosional era: the pre-1933 flood and post-1933 geometry (figure 6).

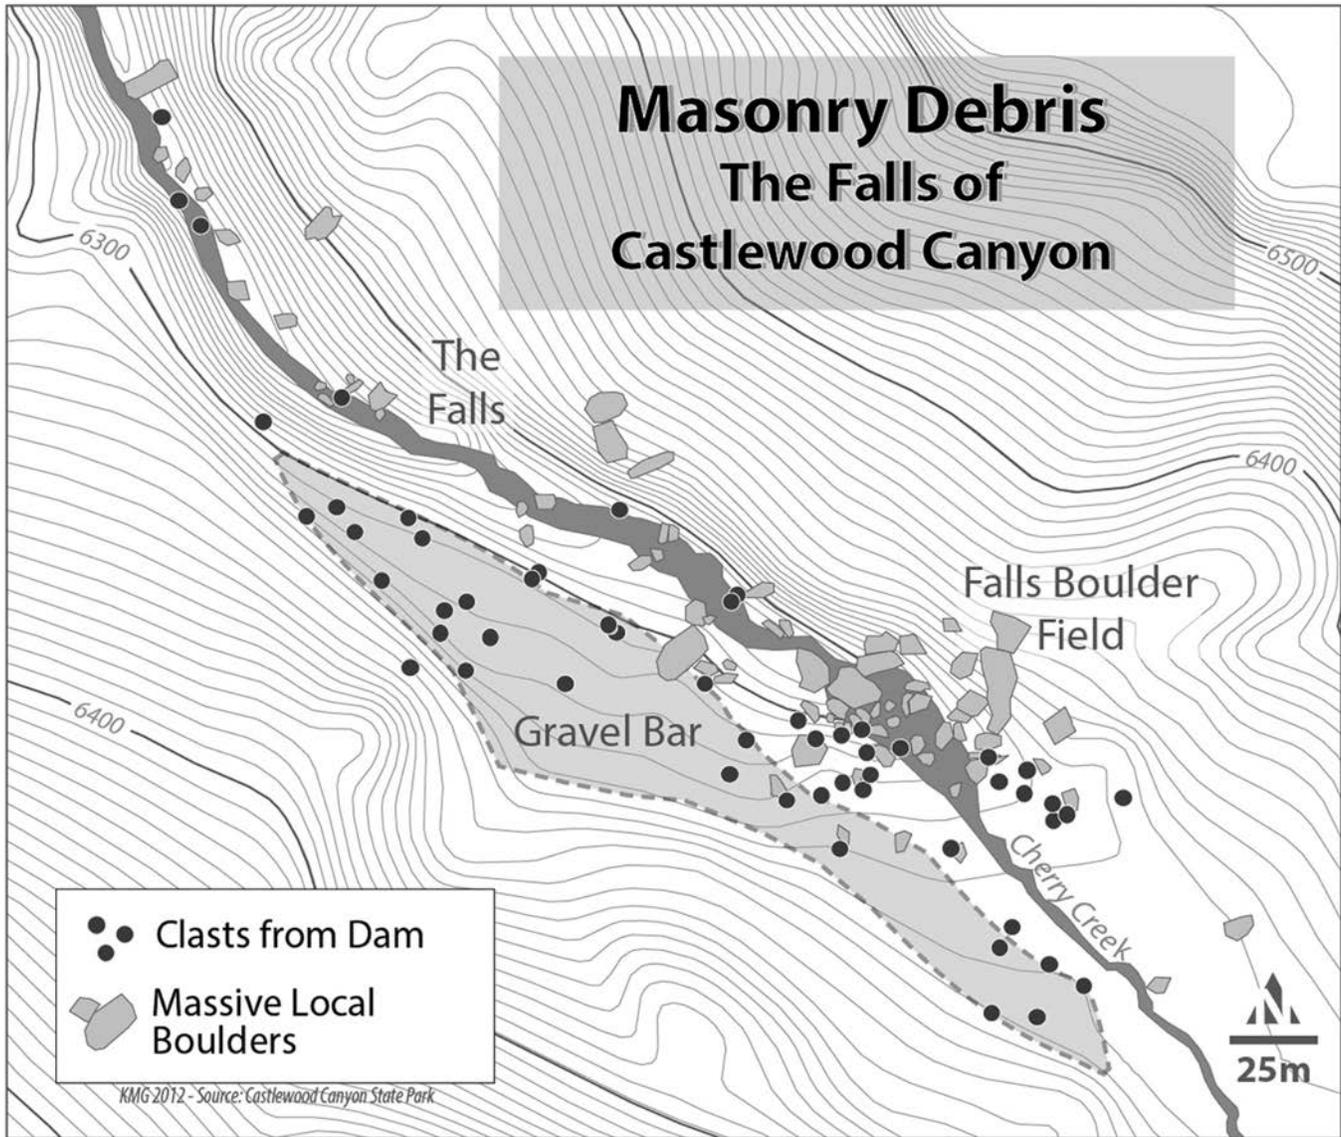
Figure 7: Map of flood debris and deposition in and around the Falls area. Kaelin M. Groom 2012.

another clue into the flood's behavior is examining where they were deposited. With basic GPS technology and identification methods explained above, spatial patterns of deposition could be mapped and analyzed. Of the 7,900 estimated boulders displaced, only 108 (roughly 2 percent) were located and identified. The disparity could be due to loss of identifying marks, thick vegetation, and the very realistic possibility of being buried beneath the massive quantities of finer sediments moved during the flood, especially since during high water events, it is typically the finer particles that are the last to settle and accumulate. As expected, the majority of the deposition patterns followed basic fluvial principles such as settling on the inner point bars with fewer in the outer cut banks, dropping in clusters where the flood lessened in carrying capacity (e.g., reduced flow competence), and so on, except for The Falls, the only known waterfalls on Cherry Creek (figure 7).
